NBSIR 79-1780

# Post-Occupancy Evaluation: A Case Study of the Evaluation Process

July 1979

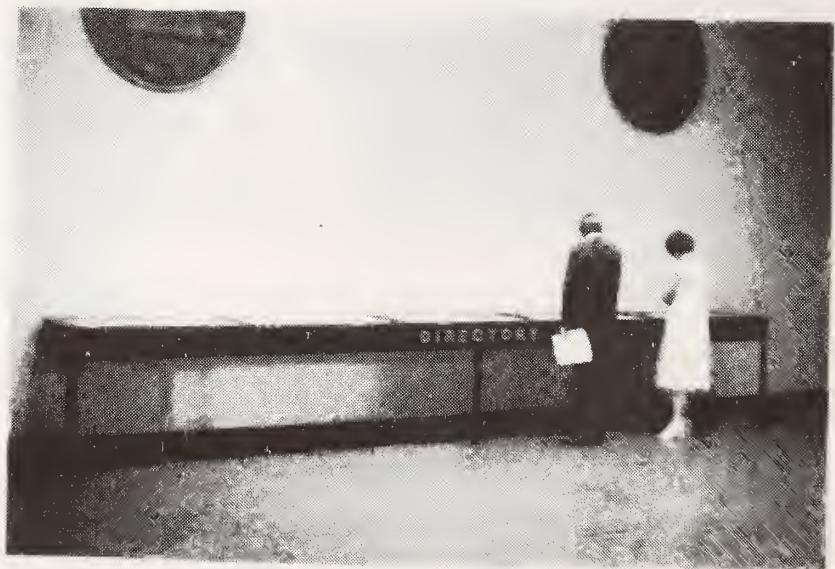
Figure 7. Building Directory

Many respondents felt the directory was hard to find and to use. The table-top format found little favor. Most users favored a wall location. The VA representative pointed out that many of the visitors to his agency were handicapped and people in wheelchairs were unable to use the directory.

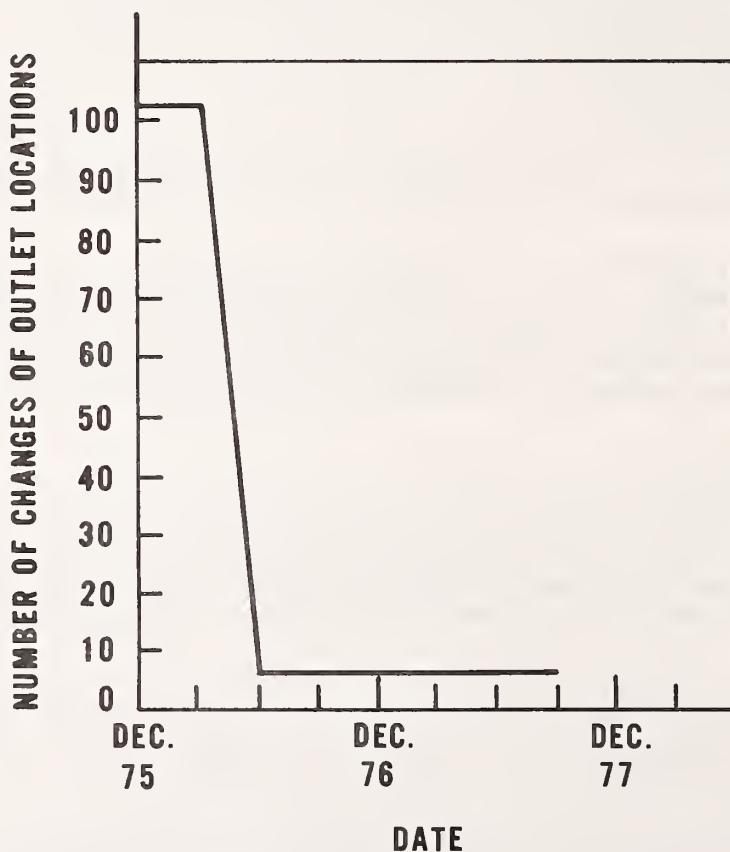
**Figure 12. Changes of Electrical Outlet Locations Since Occupancy**

them said a number of the inconvenient outlets had been removed just prior to the survey.)

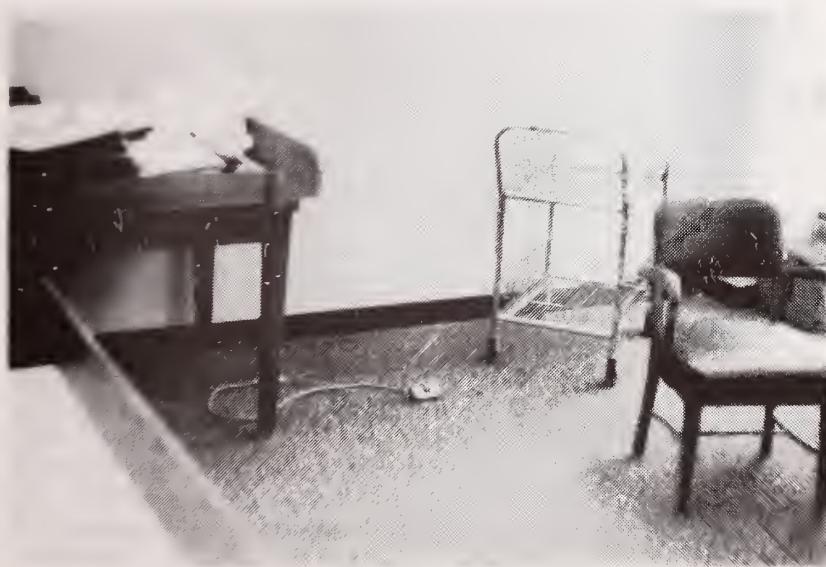
Figure 13. Loose and Uneven Carpeting

The major safety problem observed was the loose and uneven carpet sections which covered the duct system (Figure 13). Molding (covering underfloor electrical lines) was not properly replaced to prevent carpeting from pulling loose, and this became a safety hazard. Whenever telephone lines were modified, telephone company employees seldom bothered to cover the duct at all.
